ASAP Home Inspections

Home Inspection Report

119 Banting Ave, Oshawa, Ontario, L1H2M5

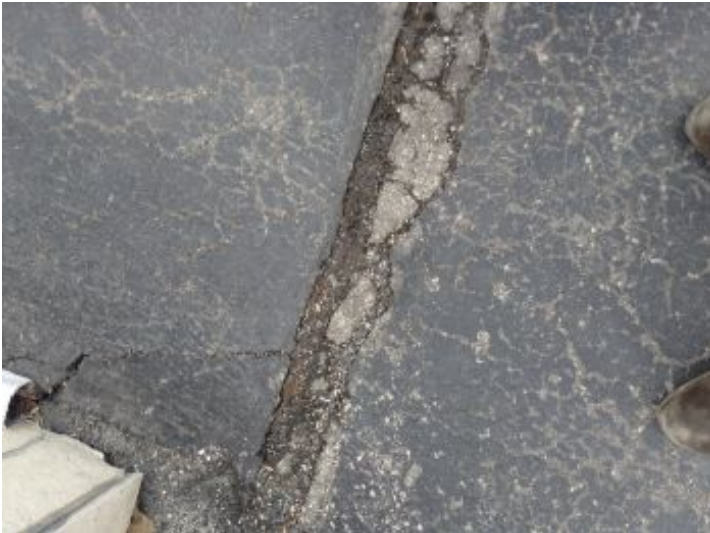
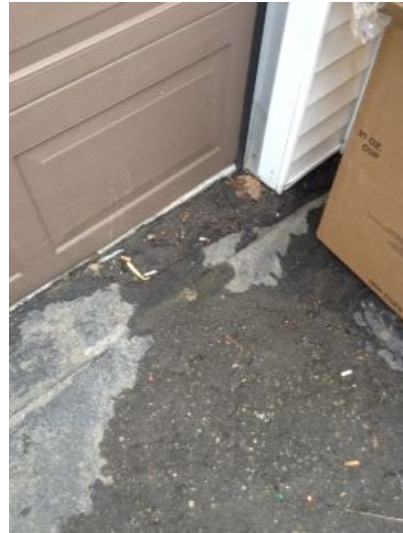
1. Driveway Condition

- Common cracks and patching noted.
- Suggest sealing/caulking the opening between the foundation and the driveway with an elastic concrete caulk.
- **Driveway is pitched towards the structure, which may result in basement seepage.**

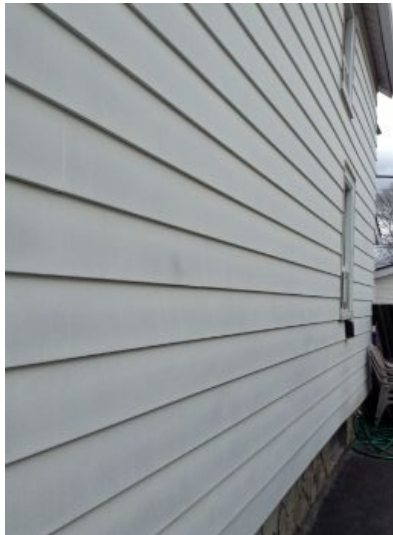
3. Exterior Wall Cladding Condition

- Areas of minor damage noted.
- Chalking observed.
- Common cracks noted.
- Suggest sealing/caulking as part of routine maintenance to prevent further deterioration.

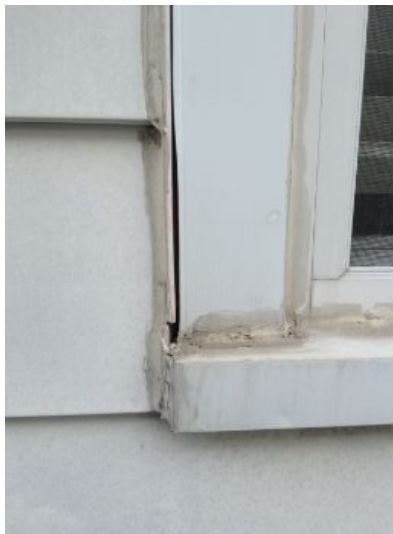
5. Window/Frame Conditions

- Suggest sealing/caulking as part of routine maintenance to prevent further deterioration.
- Damaged screens observed.

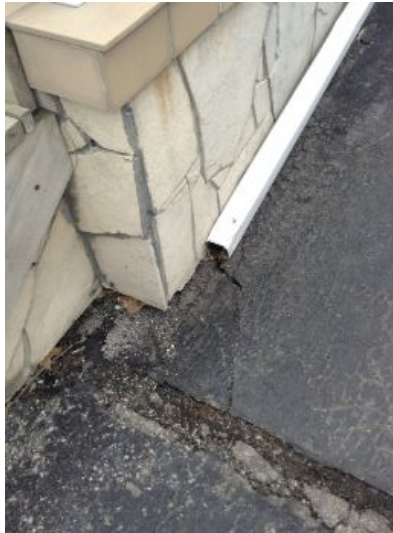
7. Gutter Condition

- Evidence of overflow observed, debris may be blocking downspouts, suggest cleaning gutters and downspouts, which should be a regular part of maintenance.
- Suggest gutters be cleaned out as a part of a normal maintenance routine to ensure proper drainage.
- **Downspout discharges water at foundation. Recommend installation of extension to ensure proper drainage away from foundation to prevent seepage.**

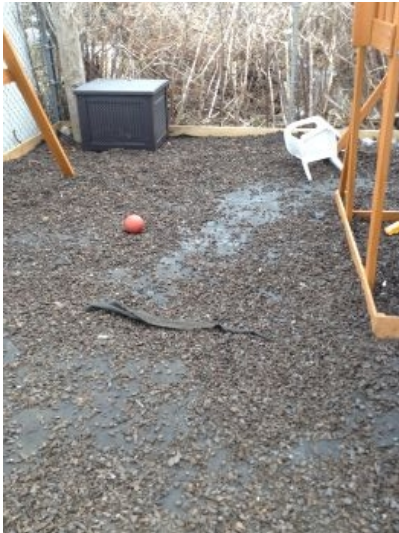
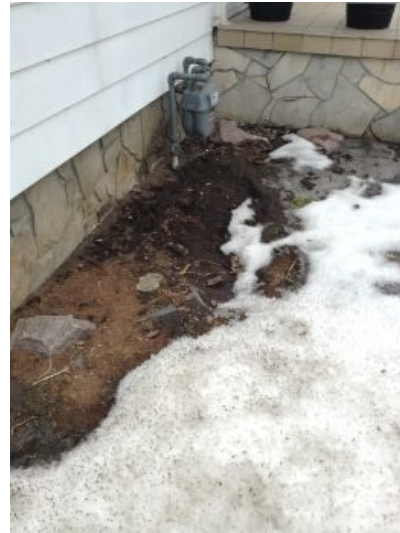
14. Lot Grade and Drainage Conditions

- No gras noted. Grass assists in absorbing water.
- Adding dirt backfill to any low lying areas located around the foundation is recommended to ensure proper drainage away from the foundation at all times.
- Older structures do not have the same drainage features as newer structures, making them more prone to seepage.

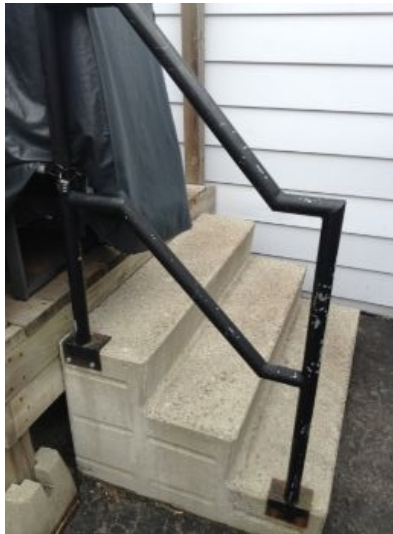
18. Deck Condition

- Deck railing is non-compliant as it offers "climbing bars" which will allow children to climb over railing. Recommend replacement by railing with vertical spacing not exceeding 4".

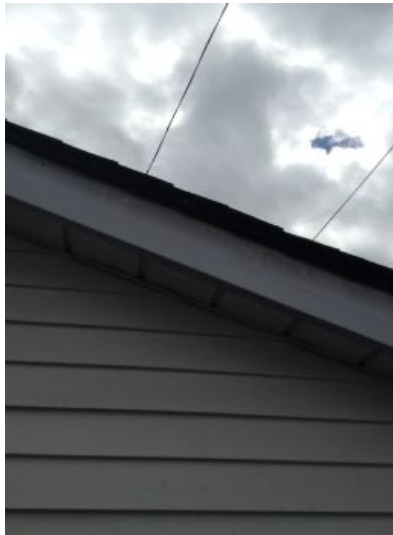
2. Garage Roof Condition

Materials: Asphalt Composition Shingles
 Observations:
 • Multiple shingle layers noted.

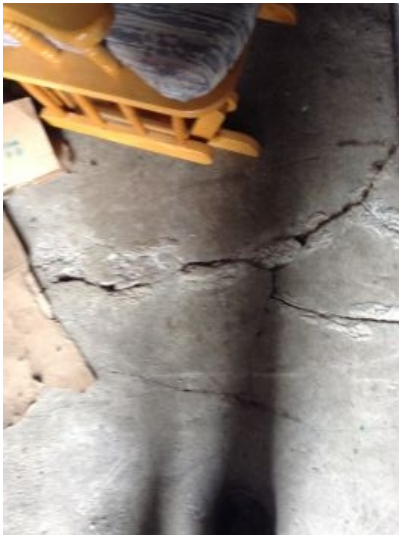
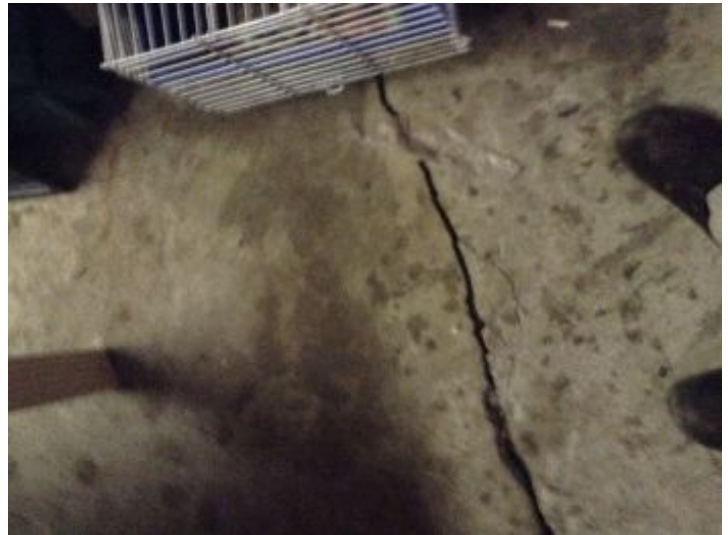
5. Garage Floor Condition

Materials: Concrete
 Observations:
 • Breakage noted.
 • Dry at the time of the inspection.
 • Expansive cracks and settling observed, suggest sealing cracks as necessary.

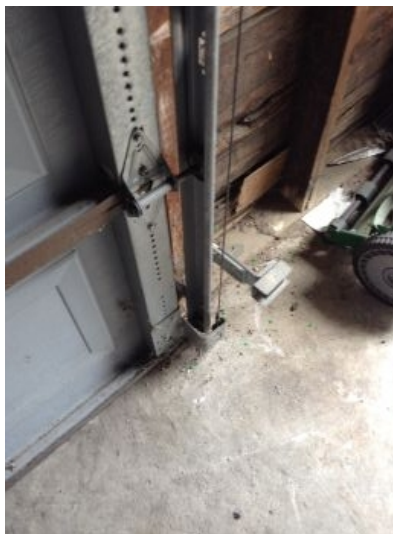
8. Garage Door Opener Condition

- Auto reverse sensors should be no more than 6" above floor. Suggest lowering these sensors for safety
- Safety reverse in place and operational

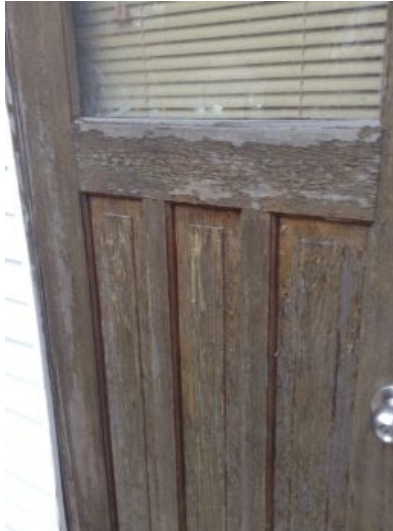
10. Exterior Door Condition

- Peeling paint observed, suggest scraping and painting as necessary.
- Water staining observed.
- Wood deterioration observed. Suggest repairs/replacement as needed.

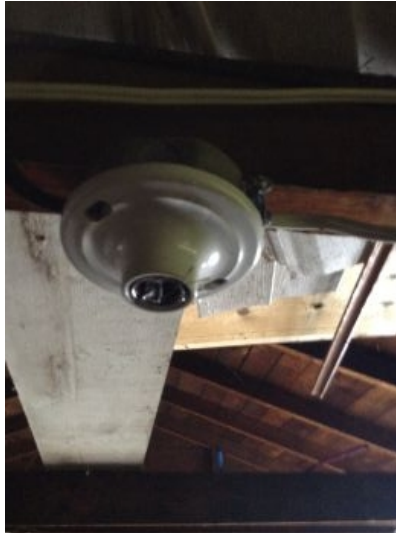
15. Garage Electrical Condition

- No GFCI protection present, suggest installing GFCI protected receptacles for safety.

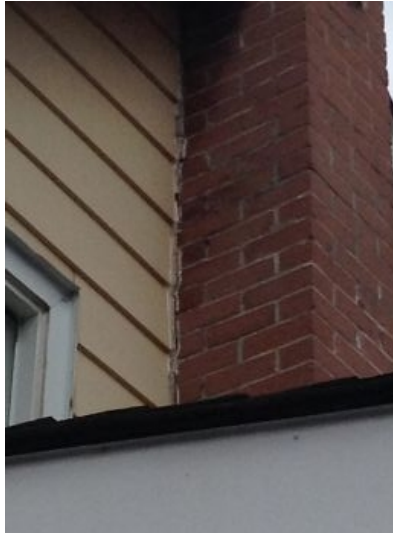
2. Chimney Condition

- Some mortar deterioration observed; advise repair as needed.
- Recommend monitoring this area regularly.
- Crown and Flashing intact where visible
- **Caulking is split.**

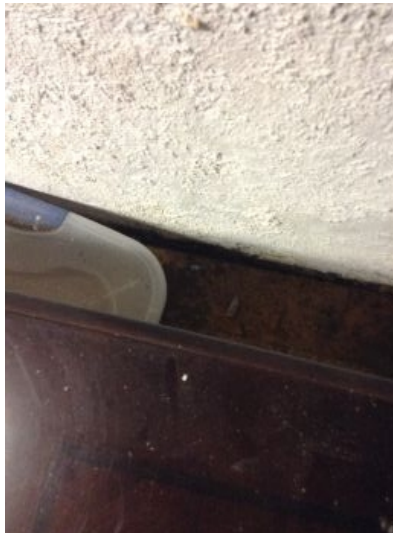
4. Basement Floor Condition

Page 18 Item: 4	Basement Floor Condition	<ul style="list-style-type: none"> • Evidence of past water penetration observed. • Wooden subfloor noted in finished area. No way to determine condition of subfloor or if water intrusion has occurred without destructive investigation. This area therefore is not within the scope of this report.

- All concrete floor slabs experience some degree of cracking due to shrinkage in the drying process. In most instances floor coverings prevent recognition of cracks or settlement in all but the most severe cases. Where carpeting and other floor coverings are installed, the materials and condition of the flooring underneath cannot be determined.
- Common cracks noted. Recommend consultation with qualified contractor should condition worsen or water intrusion occur.
- Evidence of past water penetration observed.
- Wooden subfloor noted in finished area. No way to determine condition of subfloor or if water intrusion has occurred without destructive investigation. This area therefore is not within the scope of this report.

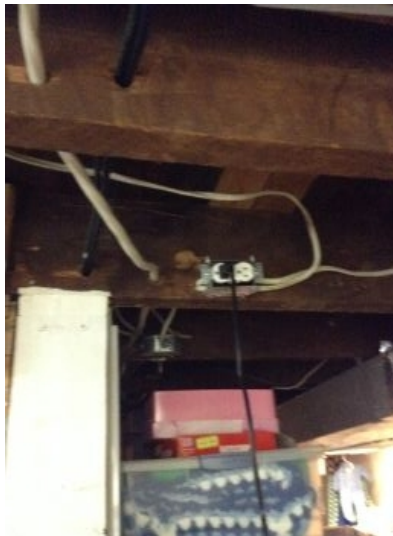
13. Electrical Conditions

- Receptacle covers missing, recommend replacing for safety.

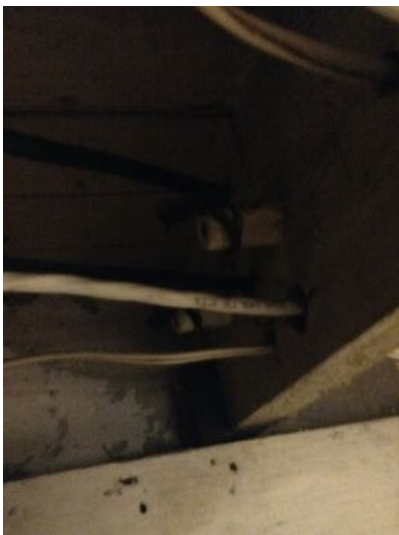
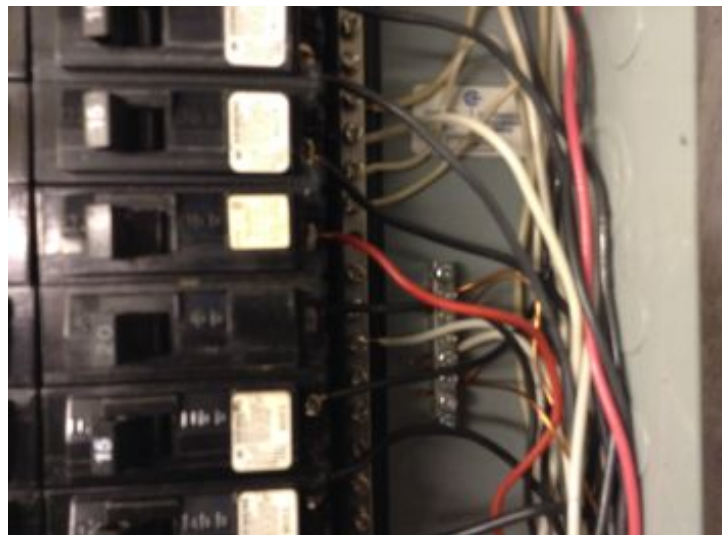
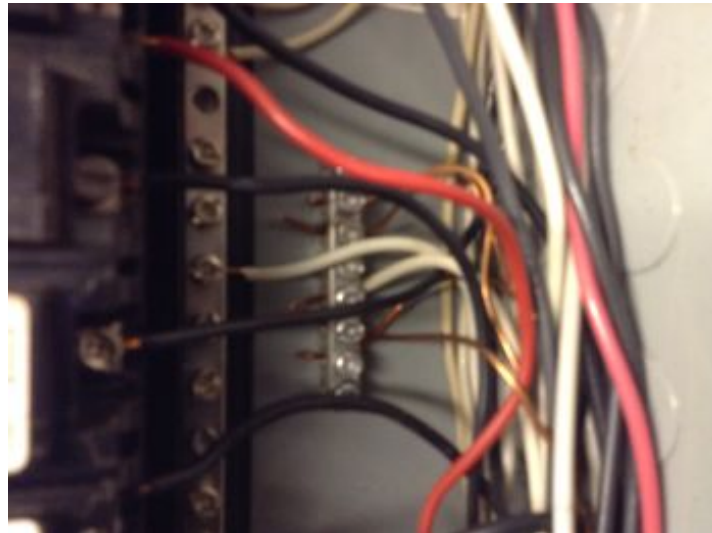
3. Main Panel Comments

- All visible knob and tube wiring appears to have been removed.
- **Neutral wire is connected to ground block Recommend evaluation by licensed electrician for safety.**

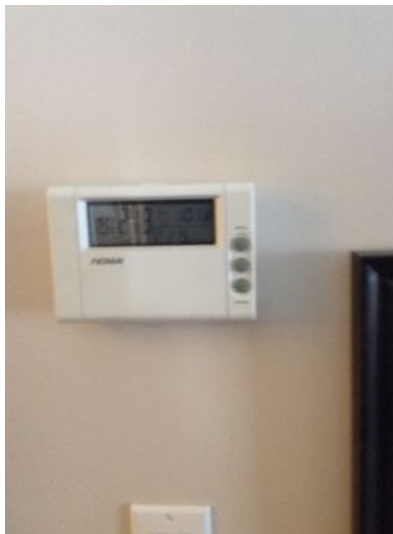
6. Thermostat Condition

- **Thermostat is too high. This could give incorrect temperature readings and affect the efficiency of the unit as air is warmer at higher heights.**

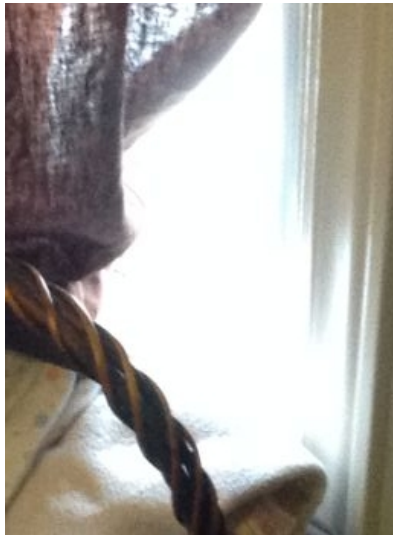
5. Window Condition

- Damaged screens observed.

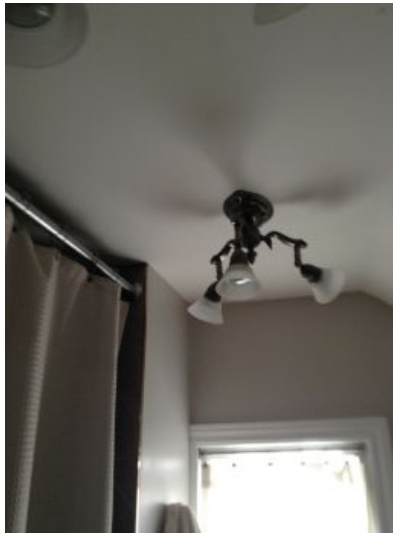
9. Bathroom Exhaust Fan Condition

Observations:
• Current guidelines state that either exhaust fan or window should be in all bathrooms to ensure ventilation of moisture. This is especially important where bathtubs or showers are present.

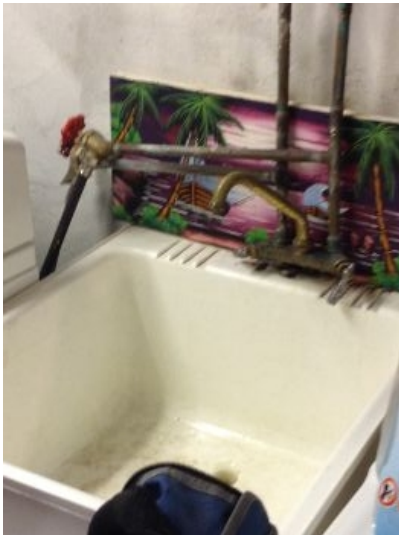
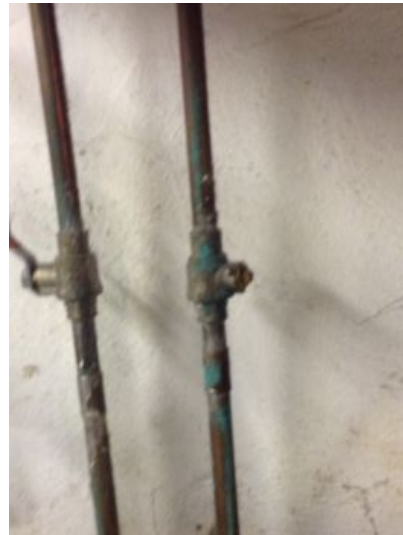
- Corrosion noted.
- **Missing shut off noted.**

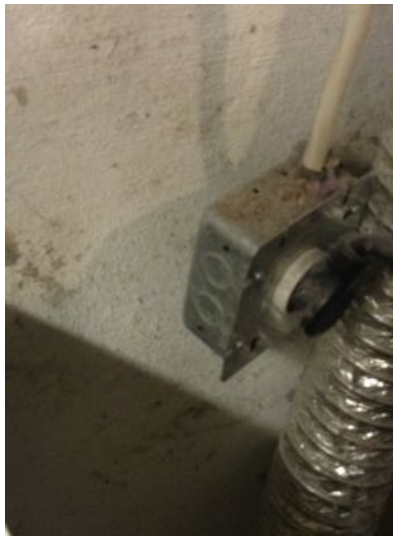
10. Electrical Conditions

- GFCI protected receptacles may not have been required when the house was built. We suggest buyer consider upgrading with GFCI's at all receptacles near water sources.

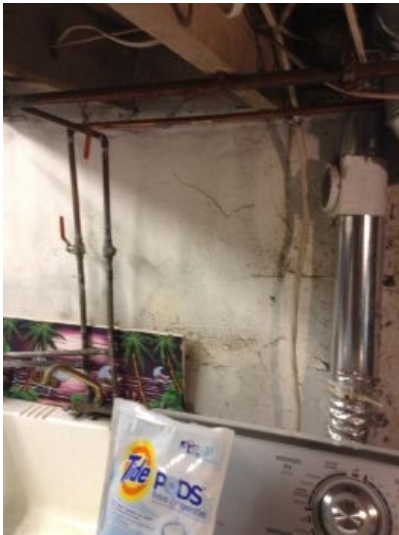
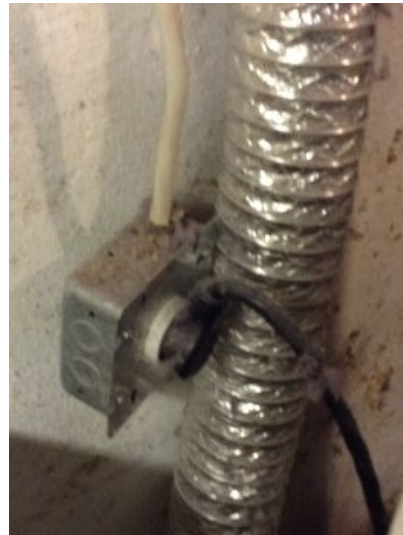
- Electric
- Dryer is not properly vented, suggest metal vent to the exterior.

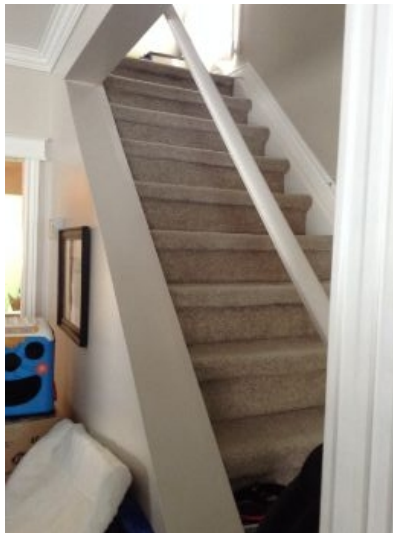
- Missing guardrails observed. This is a "Safety Concern". Although guardrails may not have been required when the home was built, we recommend client consider installing guardrails as a safety enhancement.
