ASAP Home Inspections

Home Inspection Report

119 Banting Ave, Oshawa, Ontario, L1H2M5

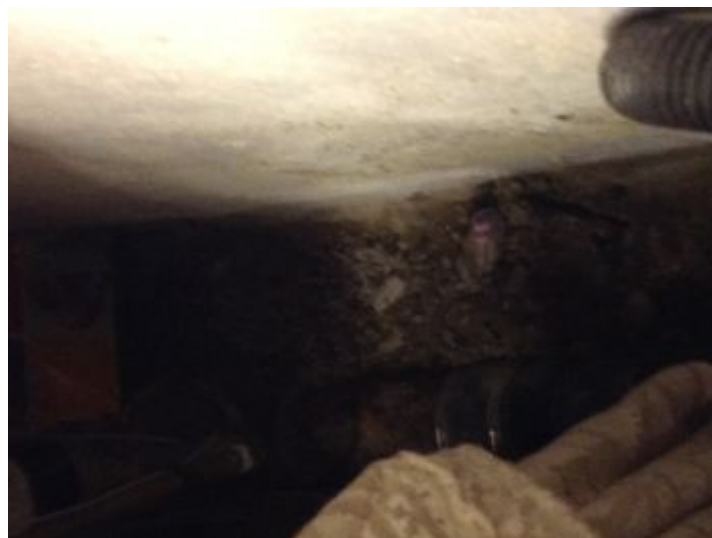
Page 18 Item: 4	Basement Floor Condition	<ul style="list-style-type: none"> • Evidence of past water penetration observed. • Wooden subfloor noted in finished area. No way to determine condition of subfloor or if water intrusion has occurred without destructive investigation. This area therefore is not within the scope of this report.

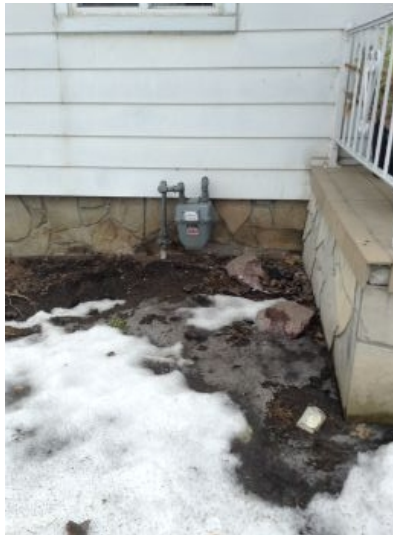
10. Gas Meter Condition

- Main fuel shutoff was located at the meter.

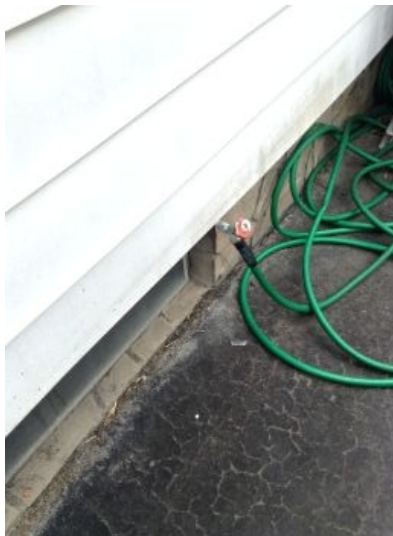
12. Exterior Faucet Conditions

- Winterized, unable to test.

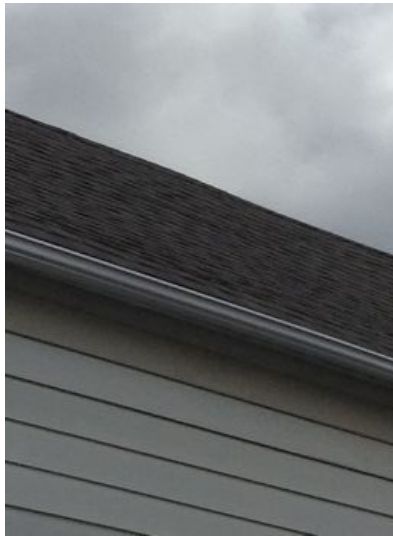
5. Roof Surface Conditions

- Relatively recent installation.
- The roof shows normal wear for its age and type.

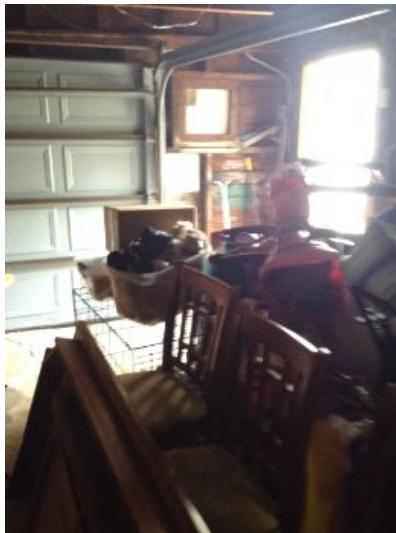
15. Garage Electrical Condition

- Limited inspection due to storage of personal property.

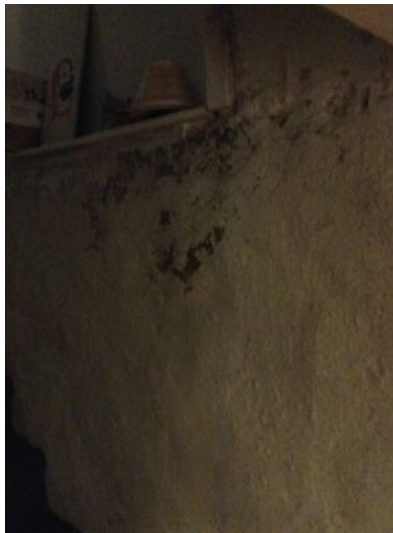
2. Foundation Comments

- Finished basement: finished areas in basement were observed. Access to the original basement walls, floors, and ceilings was not available due to the additional construction that is present such as framed out walls, covered ceilings, and added floor coverings. As these areas are not visible or accessible to the inspector they are excluded from this inspection.
- Inaccessible areas behind walls, ceiling and floor coverings are not within the scope of this report. Buyer is urged to review the Seller's Property Information Sheet to determine if any issues such as seepage have occurred in past as this inspection is limited to visually accessible items only.
- Limited view due to storage of personal property.
- Very limited review due to heavy storage of personal items.

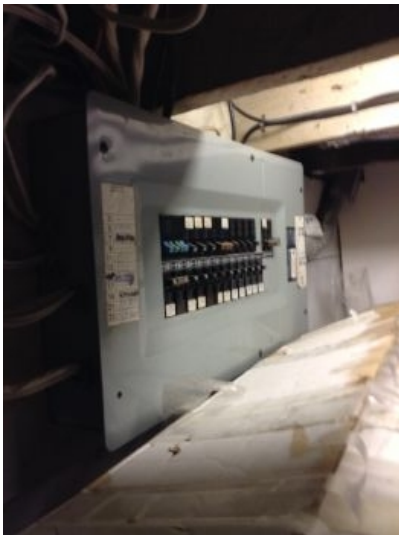
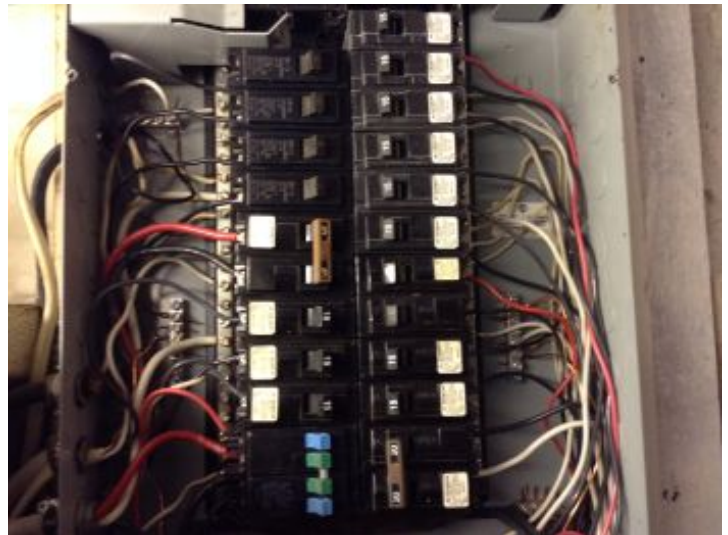
2. Electrical panel Condition

- Main disconnects are present.
- No open positions observed, box is full.
- The main service is approximately 100 amps, 240 volts.

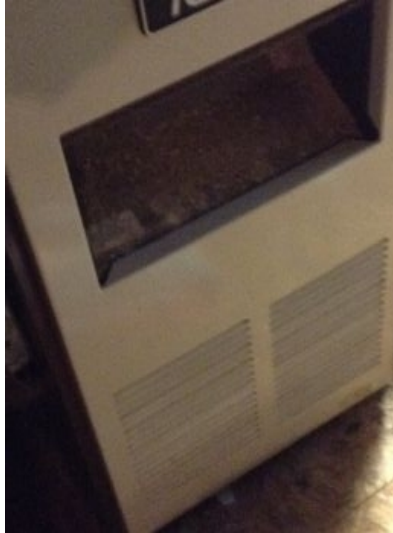
- Unable to inspect heat exchanger due to closed system.
- Furnace was mostly inaccessible at the time of the inspection.

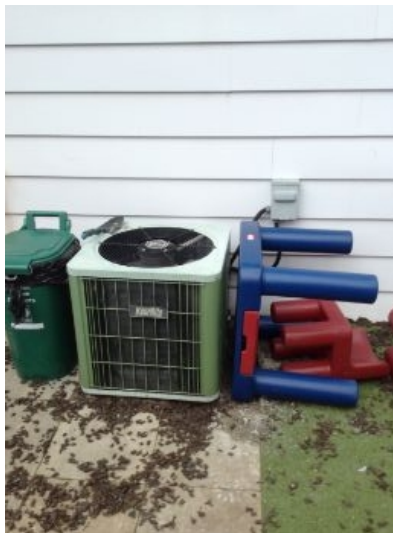
- Air conditioning could not be inspected as system was still closed down by owner. Activating air conditioning during cool/cold weather or without seasonal preparation can cause serious damage to the system. Buyer is advised to verify satisfactory operation prior to close.
- Electrical disconnect is missing, this indicates older installation.
- The condenser is tilted, excessive uneven settlement can cause fractures in refrigerant line fittings and loss of refrigerant. Unit should be leveled.

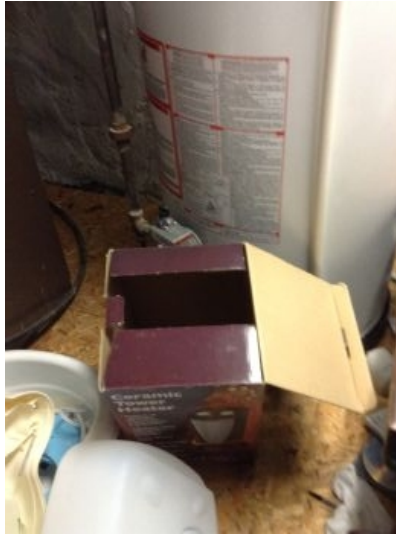
- Children should be kept away from water heater as the high pressure release valve, if disturbed, can cause scalding.

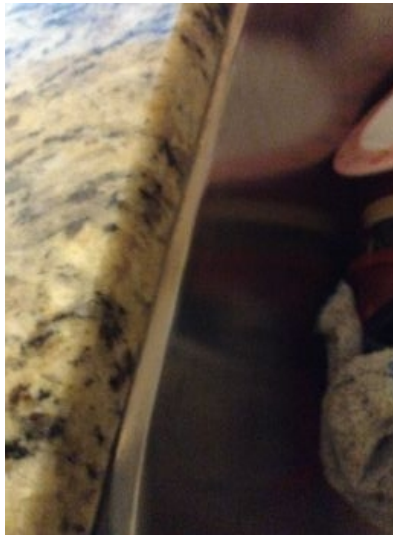
Materials: Stainless Steel
 Observations:
 • Suggest caulking as necessary.

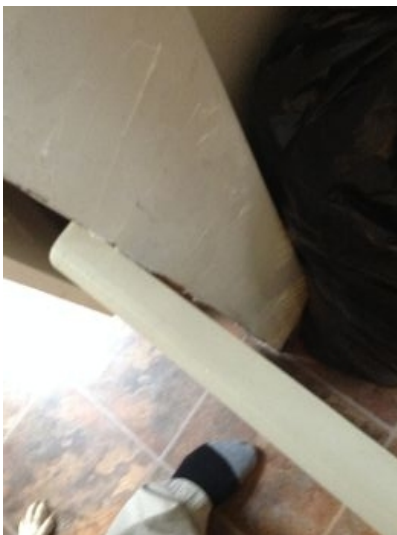
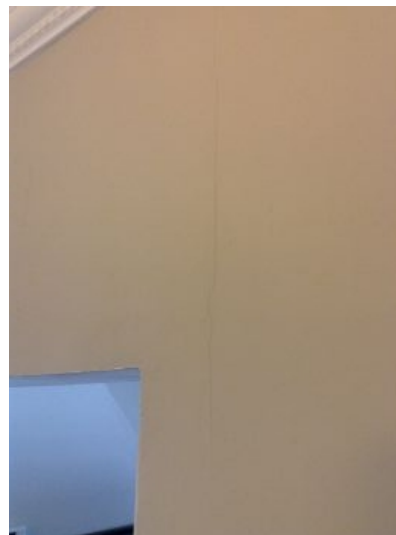
Observations:
 • Common cracks noted.
 • Dry at the time of the inspection.
 • No stains or evidence of moisture penetration observed.
 • Patching observed.
